Attachments to Appendix B

Attachment B-1

Photographic Documentation of Site Reconnaissance (2-6 March 1998)

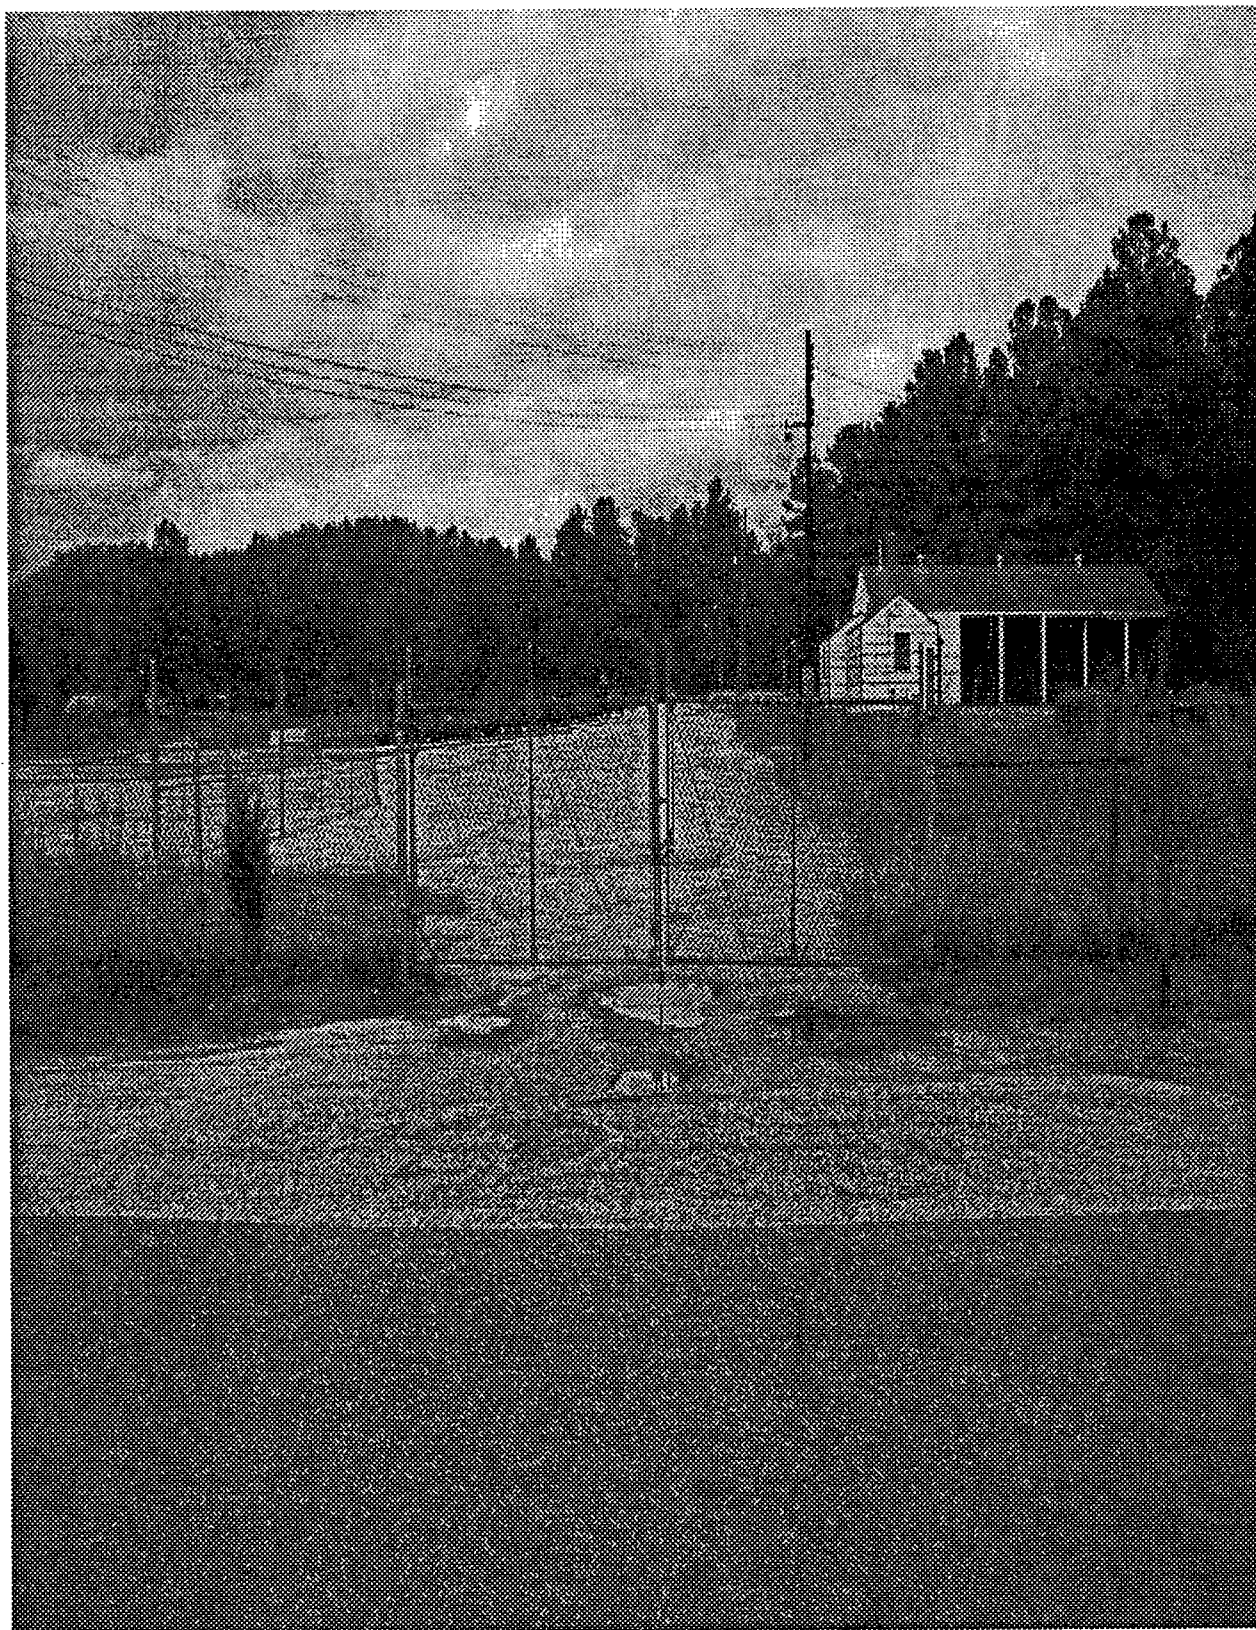
Photo A25 [3/3/98 - 2:03]

Extra exposure assumed not exposed. First exposure of next roll is the identical view (see Photo B1 for a description)
